Investigating the archaeology of the late medieval organ

Martin Renshaw

Barber Institute

Birmingham 25th Feb 2012

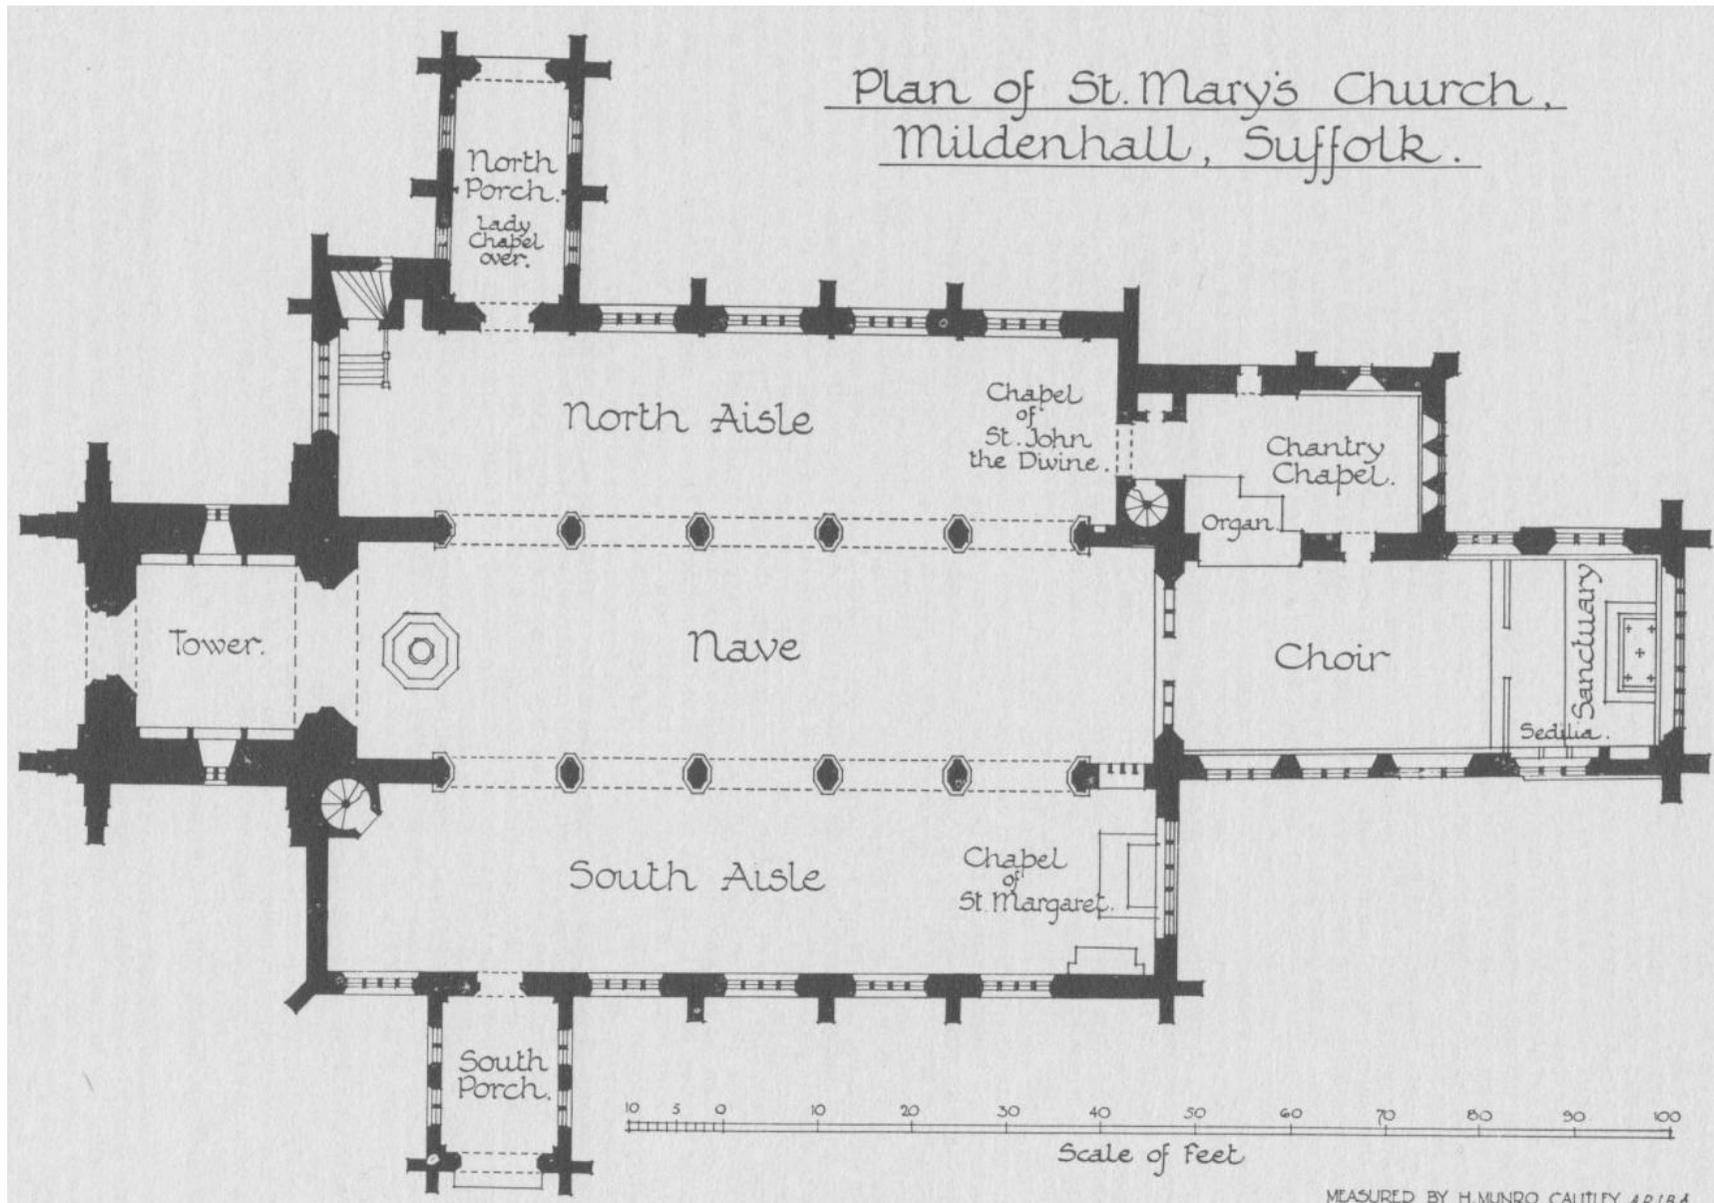
Typical plan of large East Anglian church

So the organ's musical use naturally leads the organ builder to suggest a place as near as possible to the singers, who are always placed in the chancel, or quire, so that the singer and player can get to the keys quickly and easily.

In larger churches like Clare, Thaxted or Blythburgh, there is no problem. Here the chancel aisles run almost the full length of the church and open out into the chancel with tall arches. So an organ can be placed right behind or next to the singers' benches or stalls, either on the floor or on a platform.

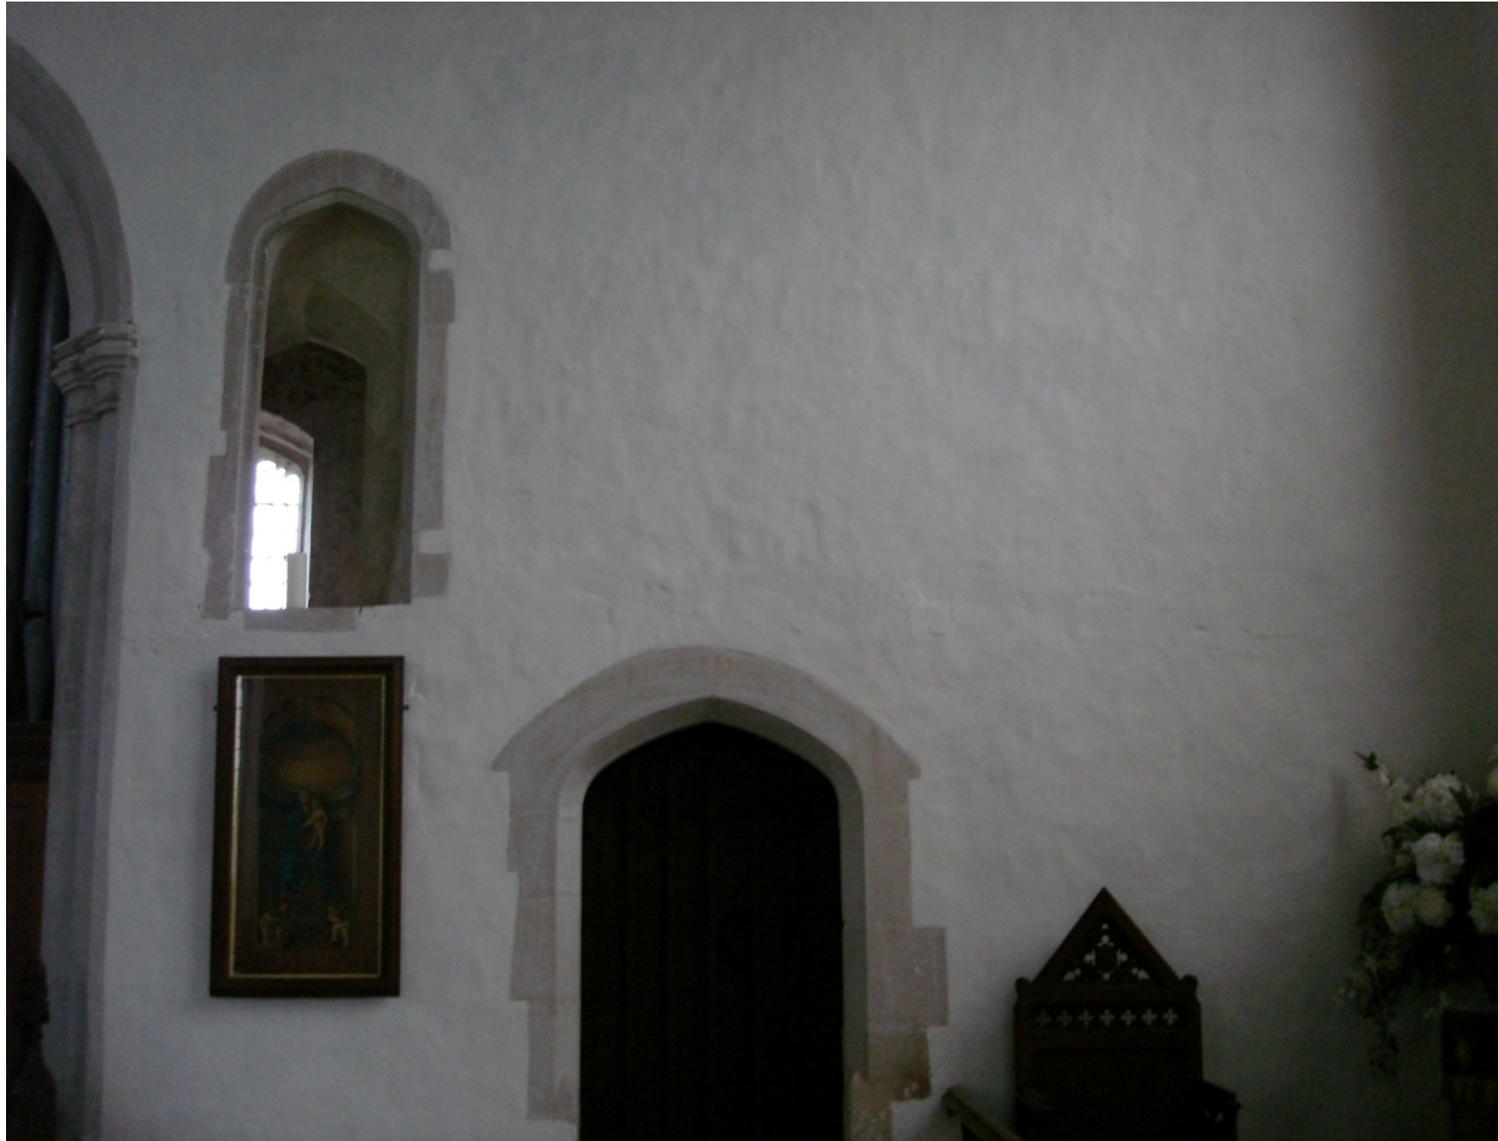
Stoke by Clare organ gallery access

The solution adopted by the organ builder was to build a platform that sticks out into the chancel from a suitable piece of blank wall. But the blank wall was not very wide, and access was not easy. So the wall from a northern chancel aisle further to the west was pierced with a doorway at the height of 8 feet, and this entry door was reached by a ladder in the aisle.

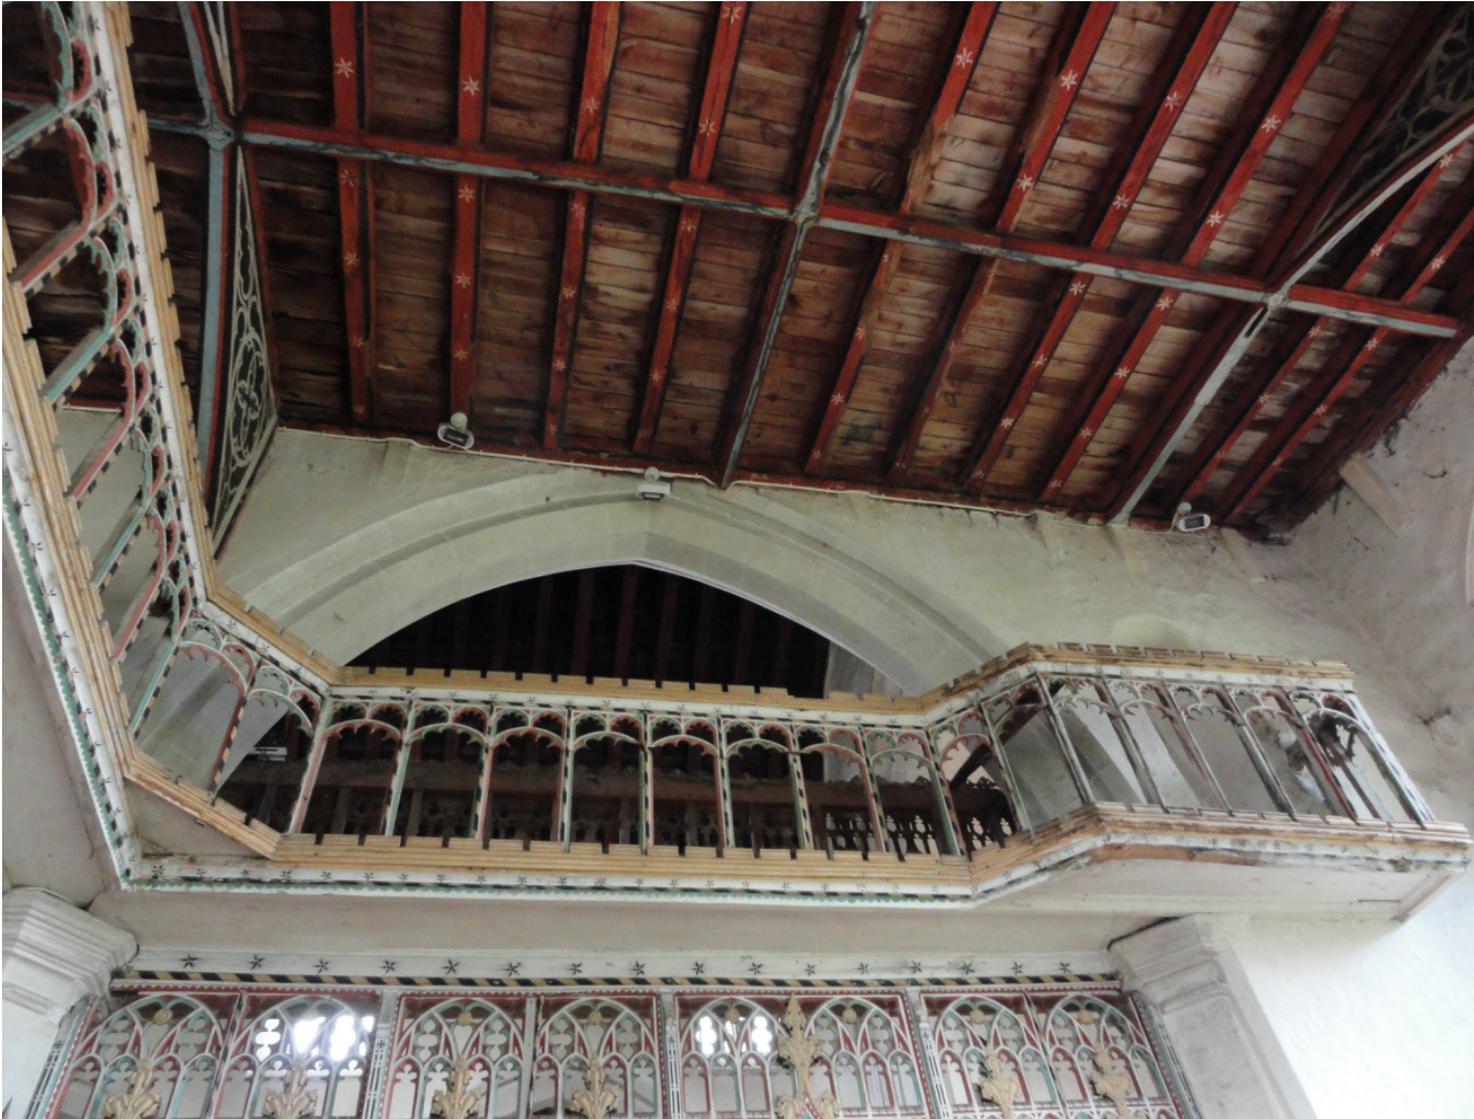
Passageway at Dennington

A passageway led from there over the vestry door to the actual organ loft. Here is a similar passage on the south parclose screen at Dennington.

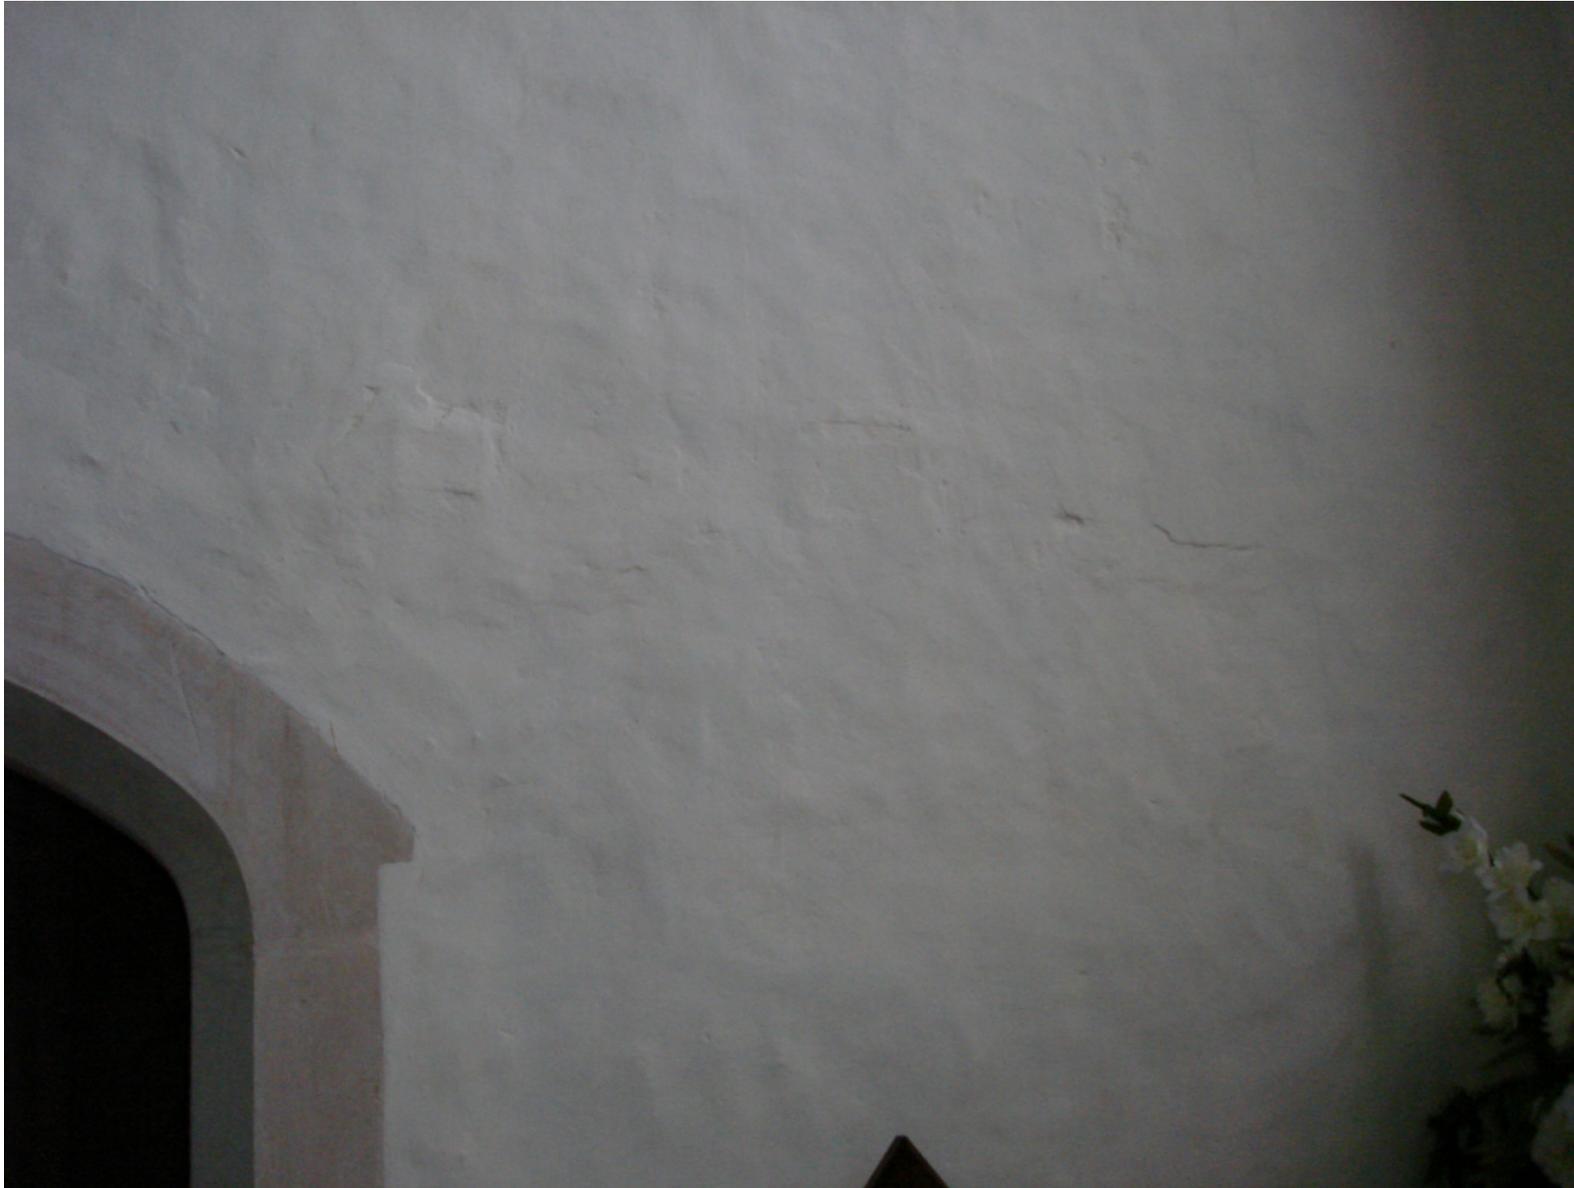
Stoke by Clare: stubs of 3 oak joists

The main weight of the organ was supported on three strong oak joists, each 5 by 4 inches, their cut ends still visible. the outer two of which...

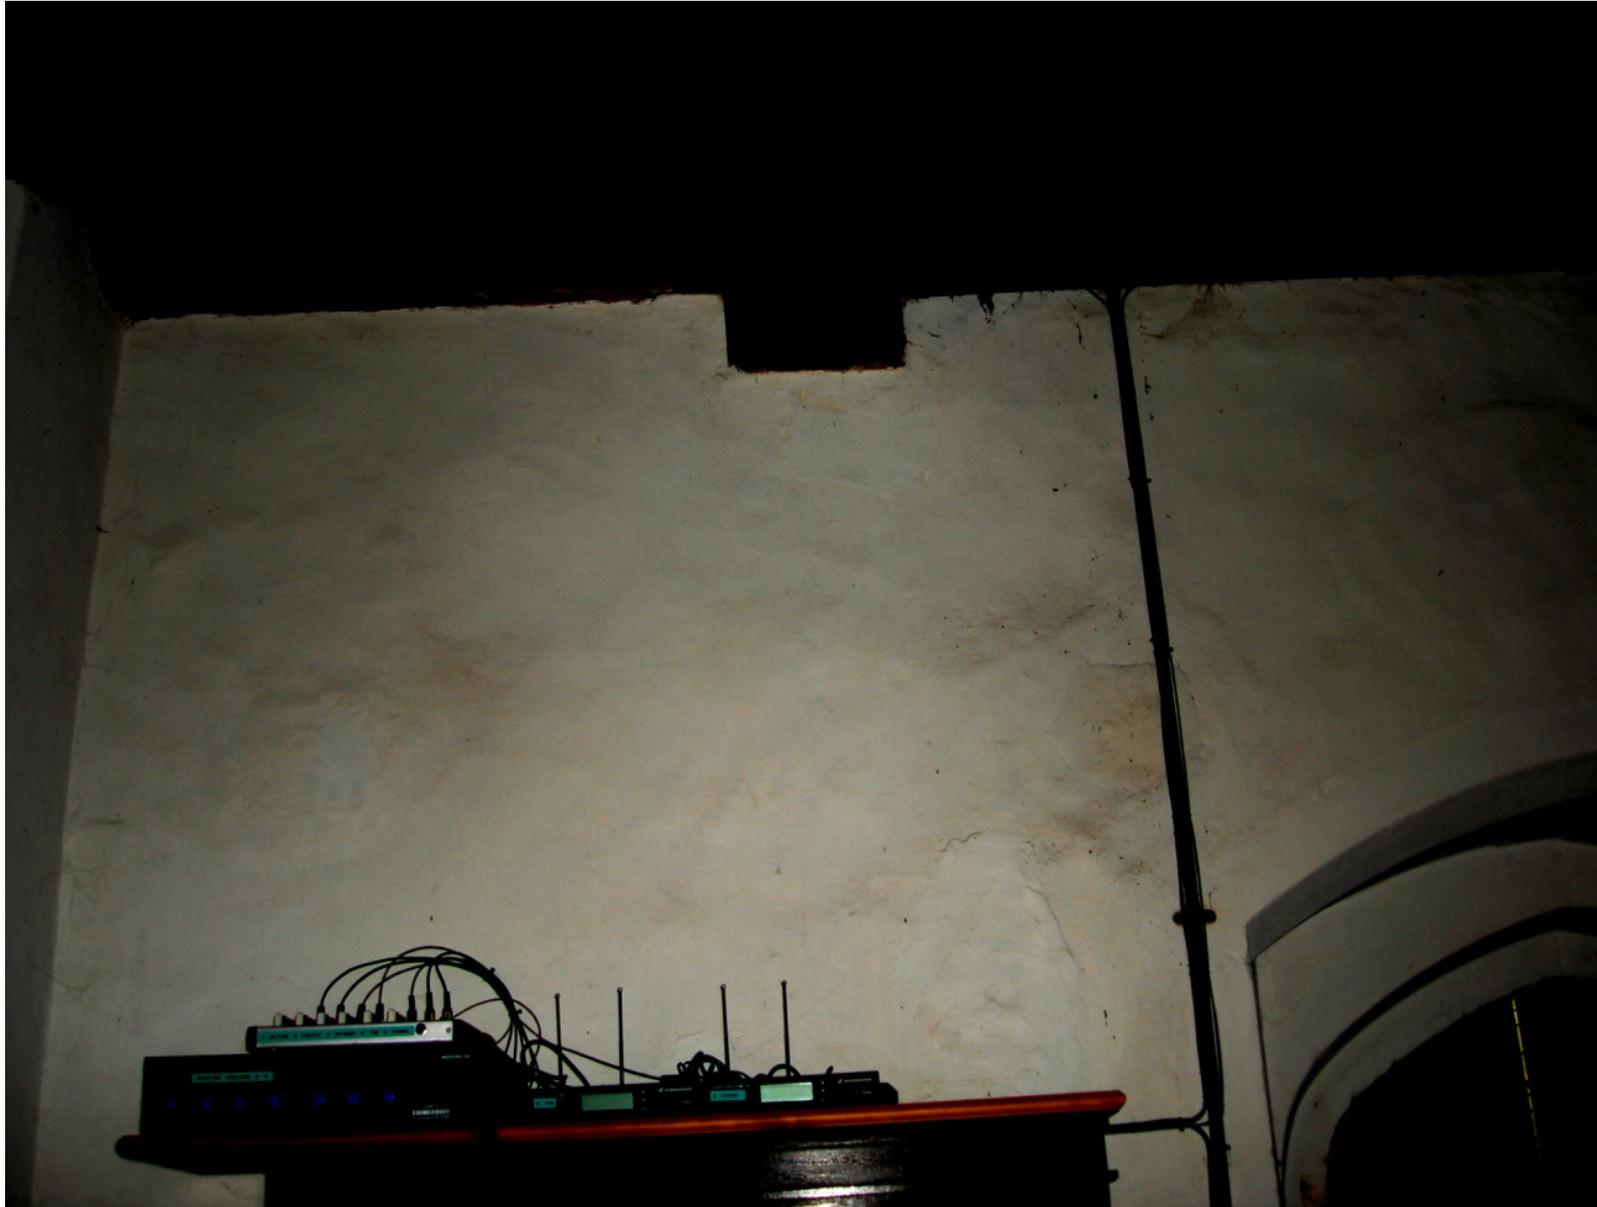
Stoke by Clare: 2 joist stubs inside vestry

...4 feet apart, went right through the 30" wall into the vestry behind.

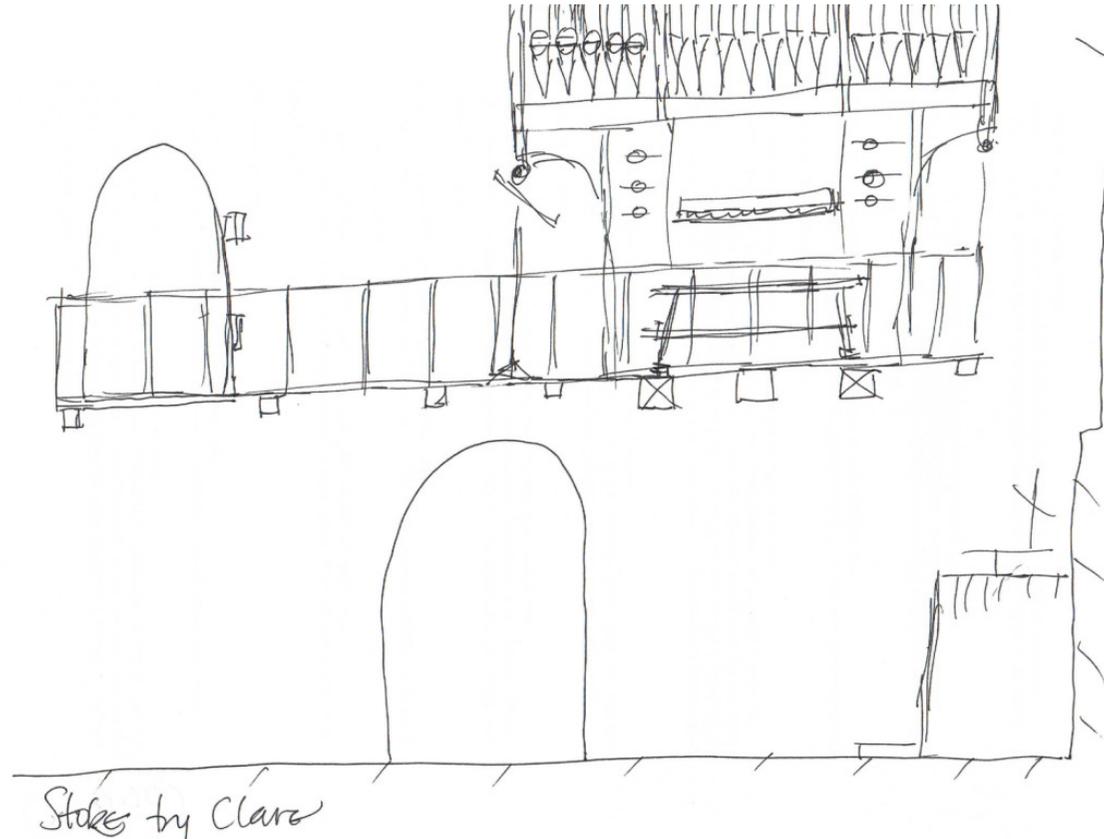
Stoke by Clare

A gallery up to about 7' 6" wide was the result, with a high-standing organ on it whose casework could have gone up a further 12 feet or so. This gallery could have been up to about 3 feet from front to back without obscuring the east window too much.

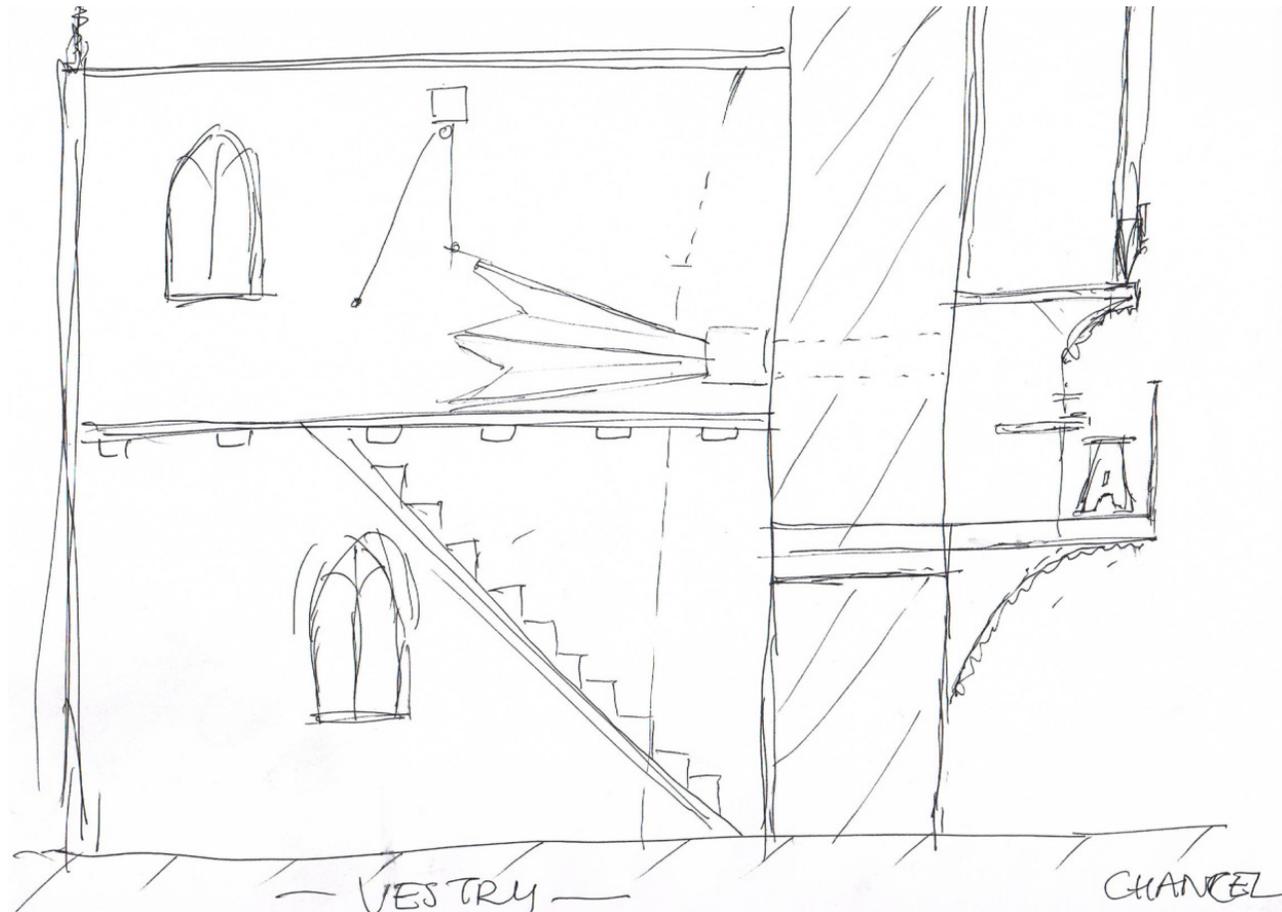
Stoke by Clare cross section

But where were the bellows? Let's look at a cross-section of the vestry and church. You will see that there are two stories in the vestry, the upper floor being 10' 6" above church floor level. Perhaps the upper one is at just the right height to feed wind into the organ's main soundboard? What they did at Stoke is not yet certain, but as we shall see later, there is another church not too far away where this did happen.

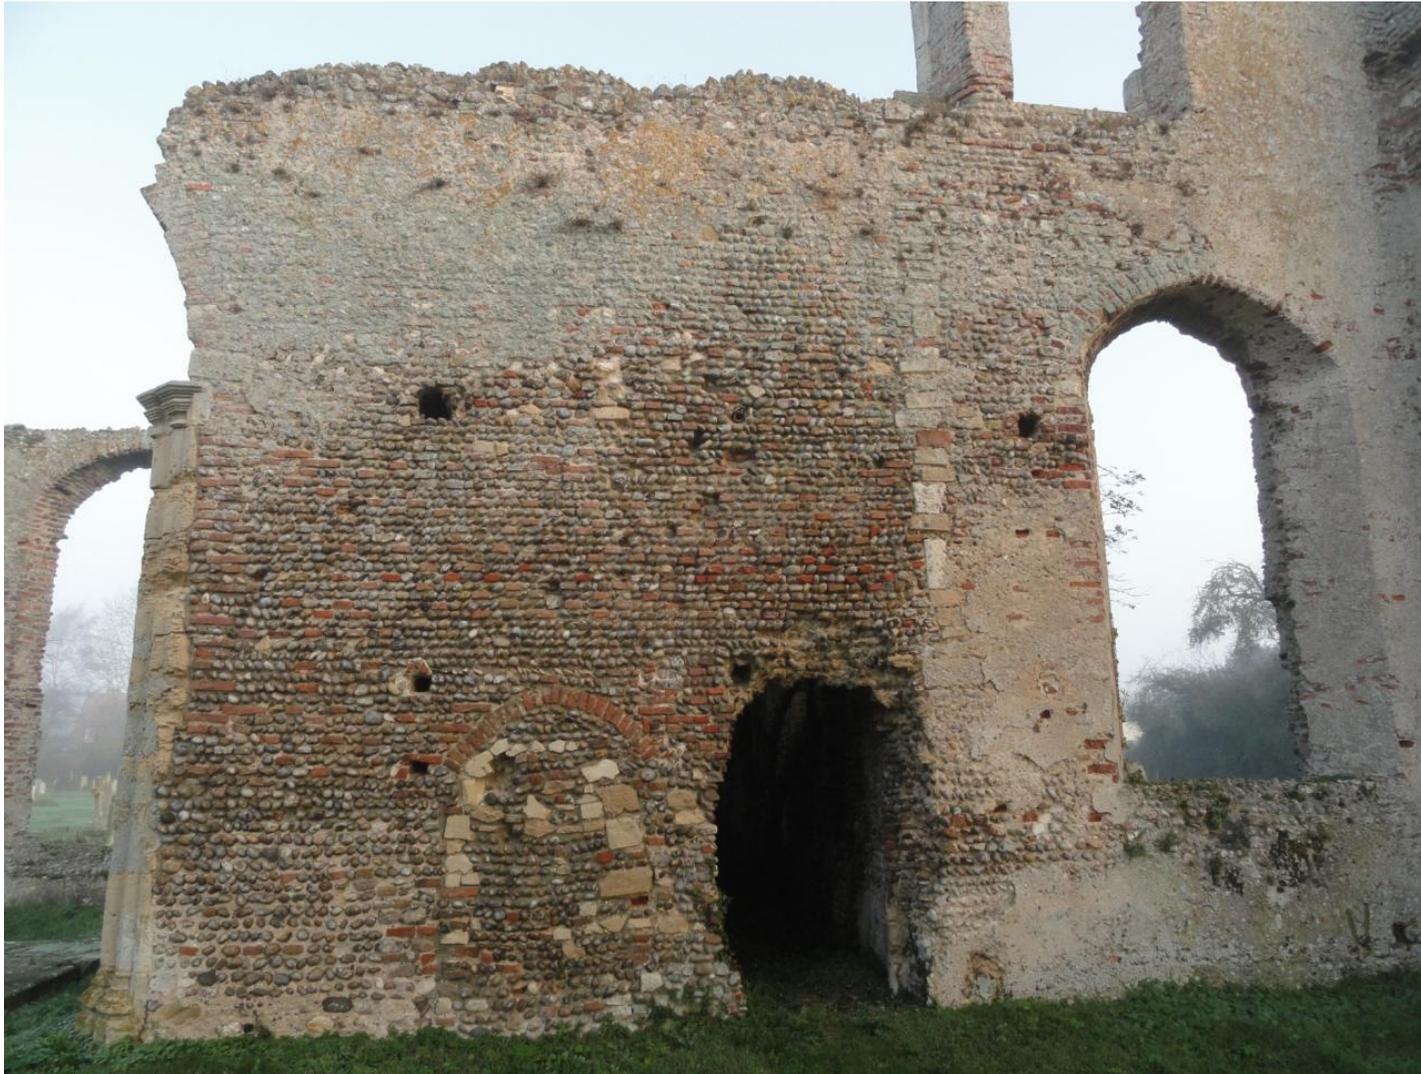
Walberswick: north chancel wall

The same gallery or loft solution - but on a much larger scale - was adopted at Walberswick. This is a coastal church the same size and in some ways even finer than Blythburgh nearby, but it fell on hard times in the mid-1500s. Here very clearly are all the signs of a wide and very high loft – its floor was a vertiginous 14 feet high.

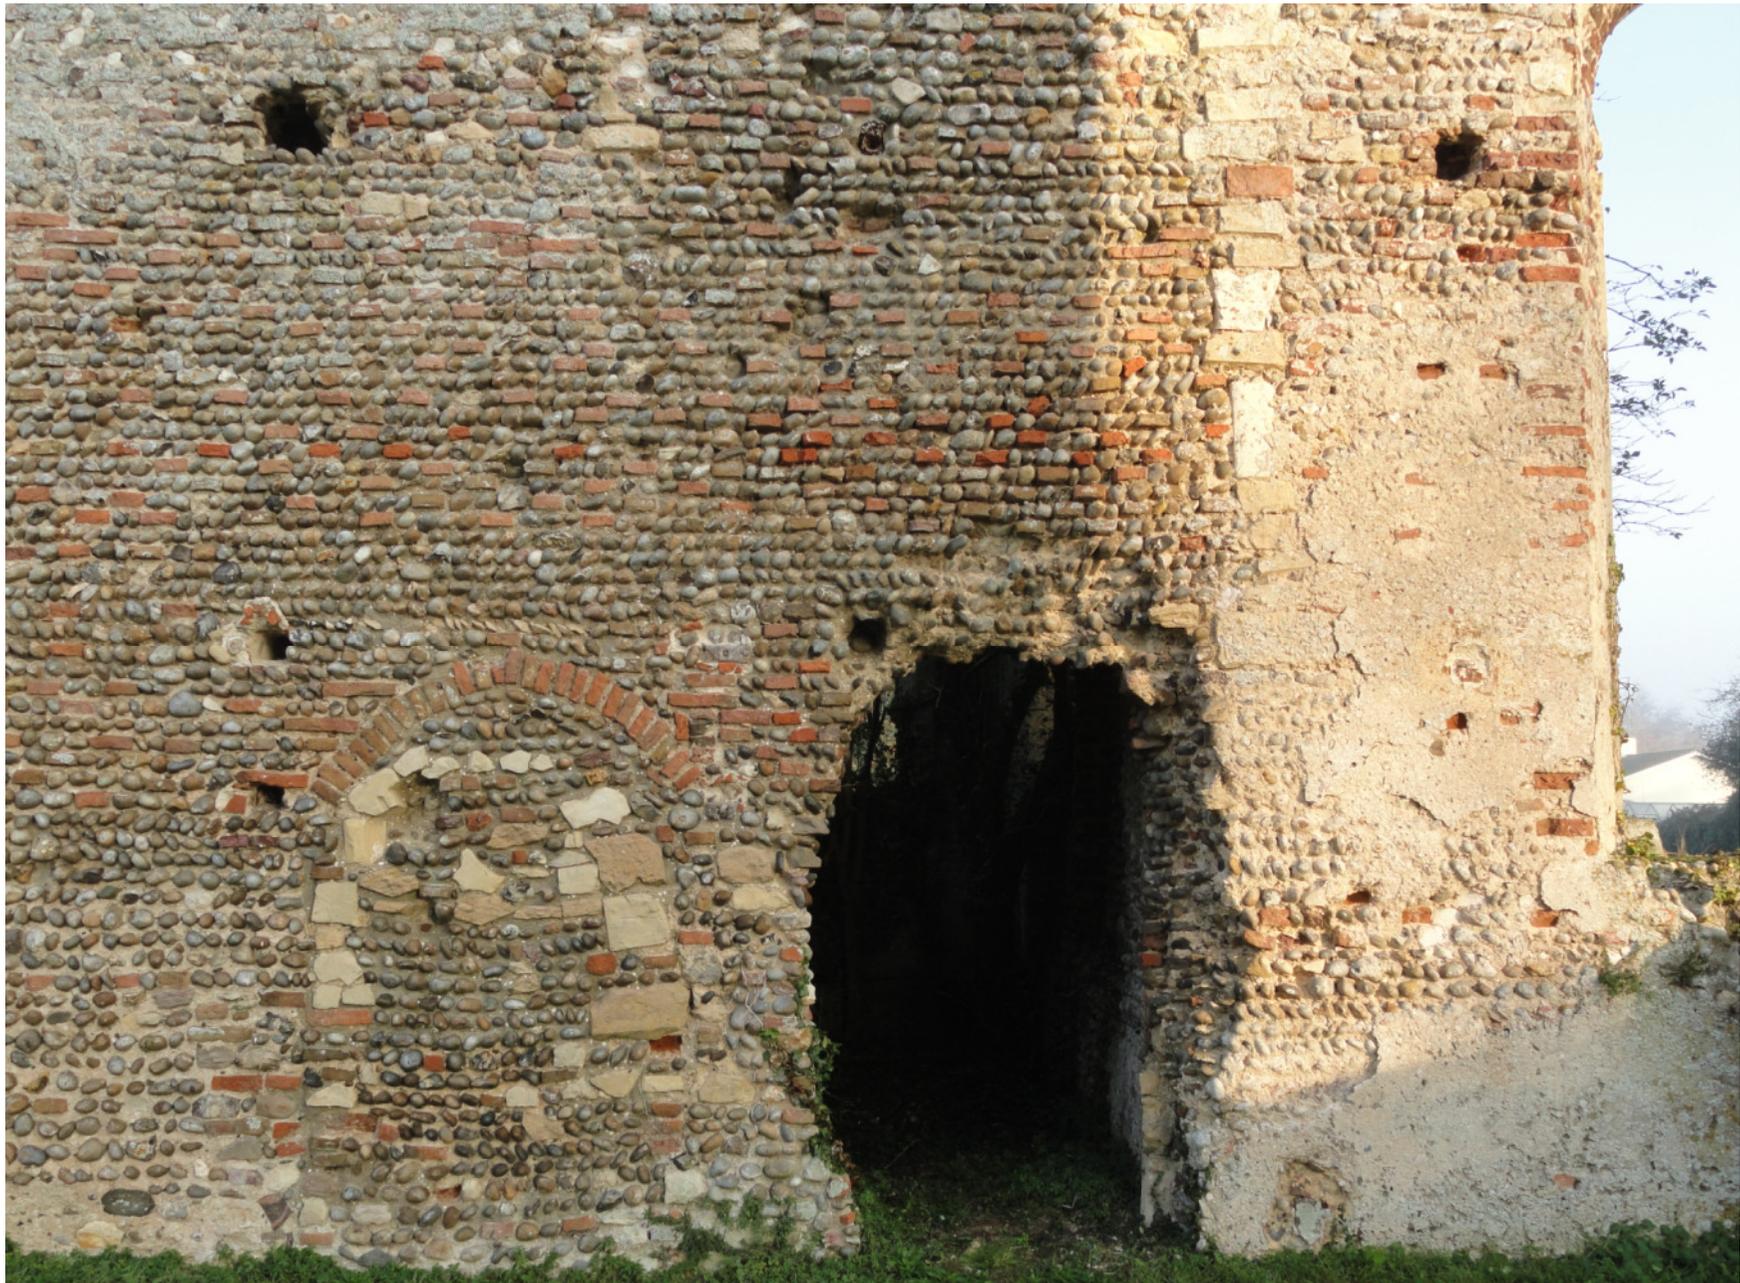
Since the plaster long ago fell from the north sanctuary wall, you can easily see the sockets of joists and their supporting timbers.

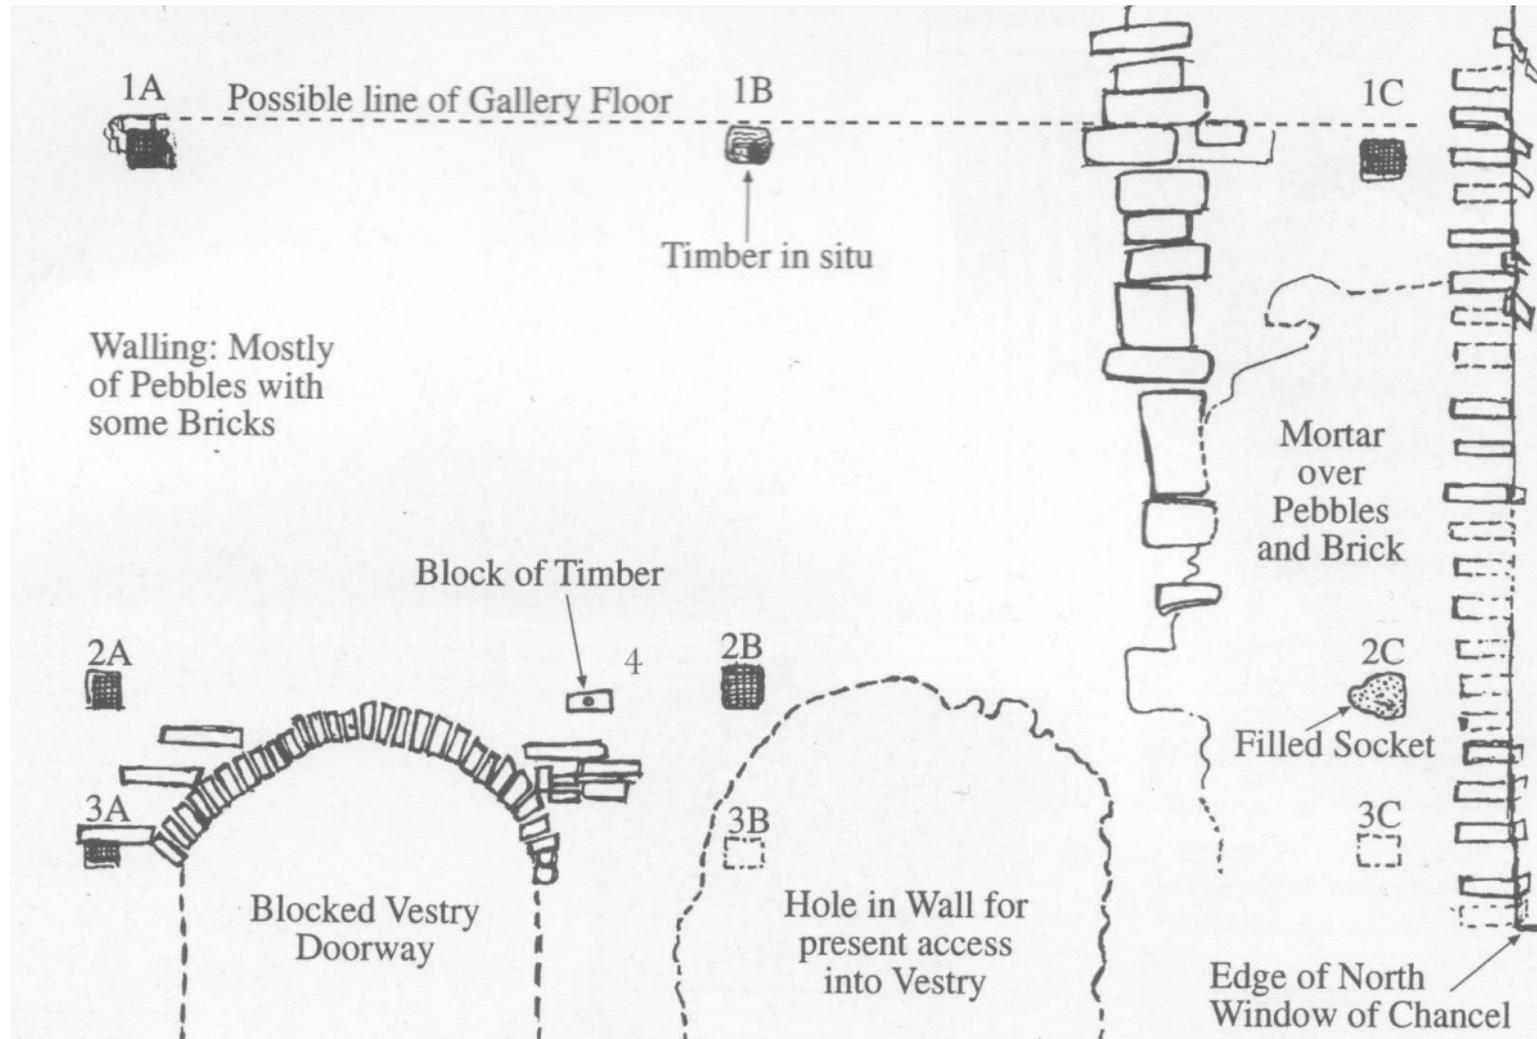
Walberswick: north chancel wall

This would have carried a large organ – it cost at least around 15 pounds sterling, possibly 20 - and it could have been a further 15 feet high above this already-high gallery level, as the wall it is against goes up at least 30 feet.

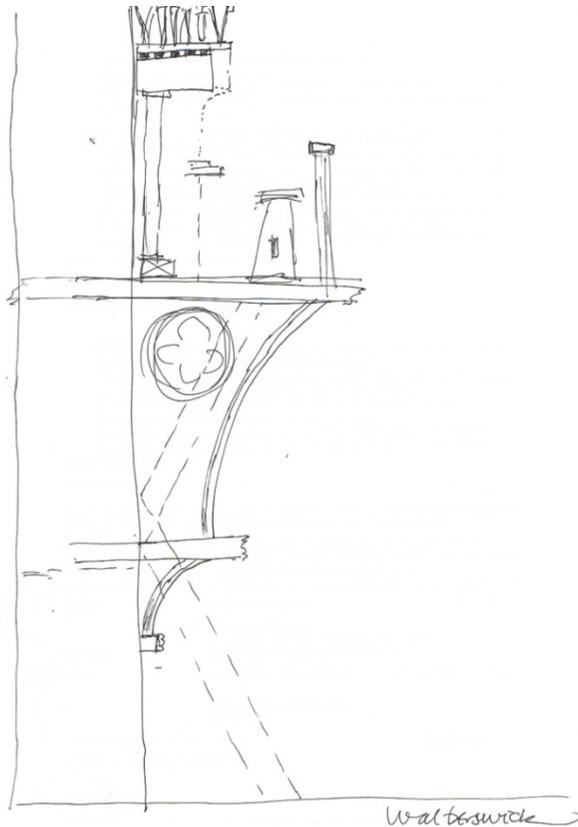
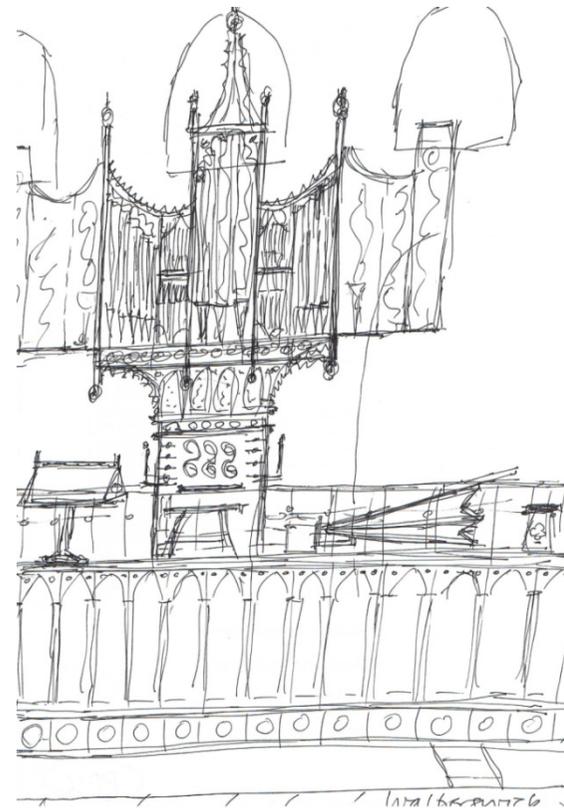
Walberswick: reconstruction

Here the access must have been by a staircase, perhaps at its western end as there are no signs of any other access, unless the wall behind the organ has been substantially rebuilt since this part of the church was abandoned, which seems unlikely. The gallery's width here at Walberswick was at least 15 feet, and that is wide enough for it to contain the bellows for the organ as well as access. There is a two-storey vestry behind it, but there are no obvious signs of a wind-trunk hole through the wall between it and the gallery. The building history of this part of the church needs to be investigated further as it is obvious that the access to the vestry has been altered for some reason.

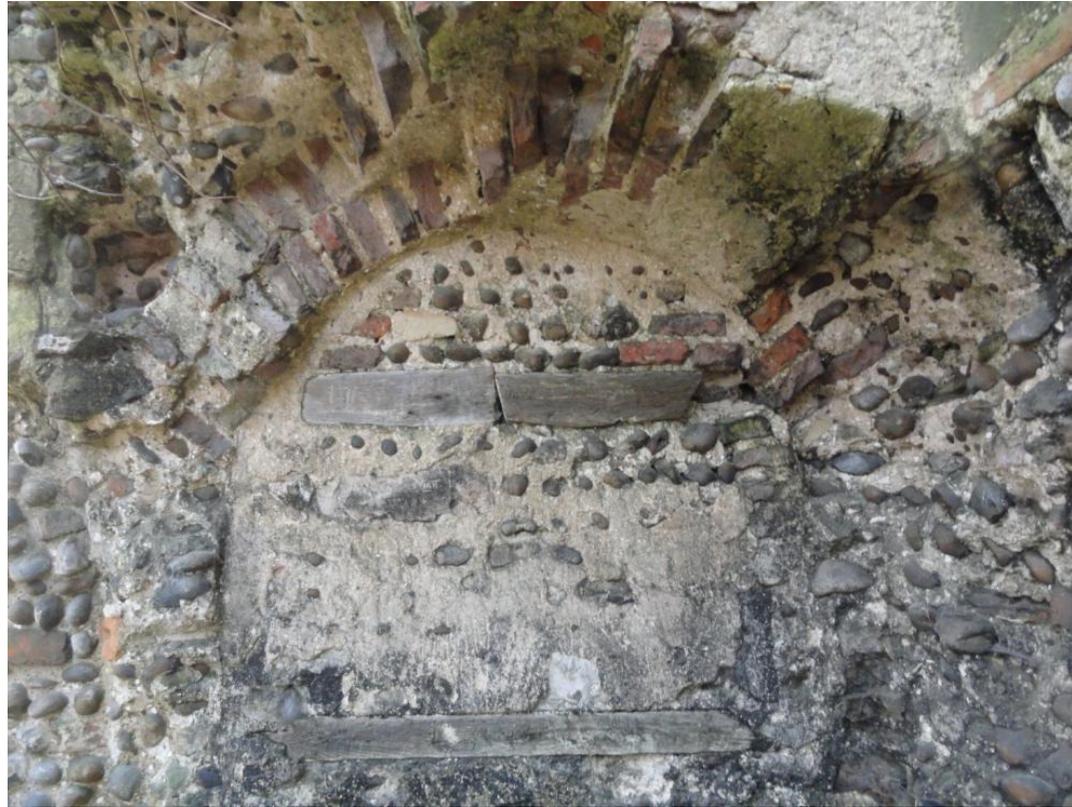
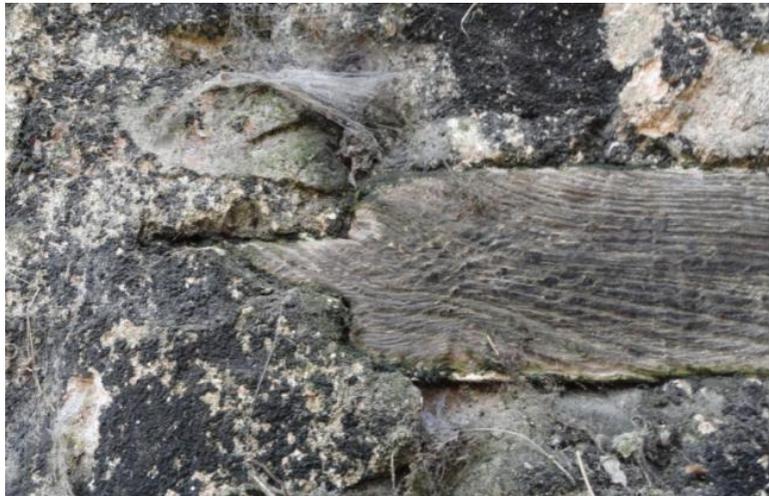
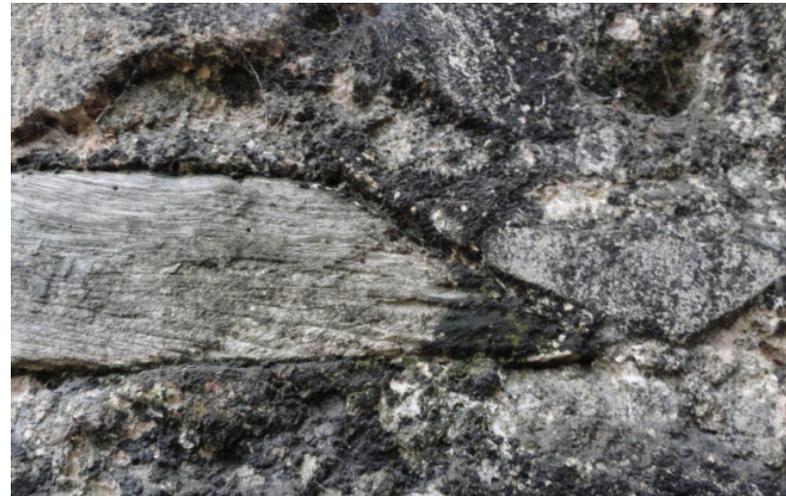
When the presumably-original vestry doorway was blocked, some pieces of wood were used as part of the filling material on the inner side, and could have been part of the structure of the loft. One has a very suggestive 45 degree tenoned end, and this may have been an angled strut supporting the front of the gallery structure, which seems to me to have been a sort of hammer-beam arrangement...

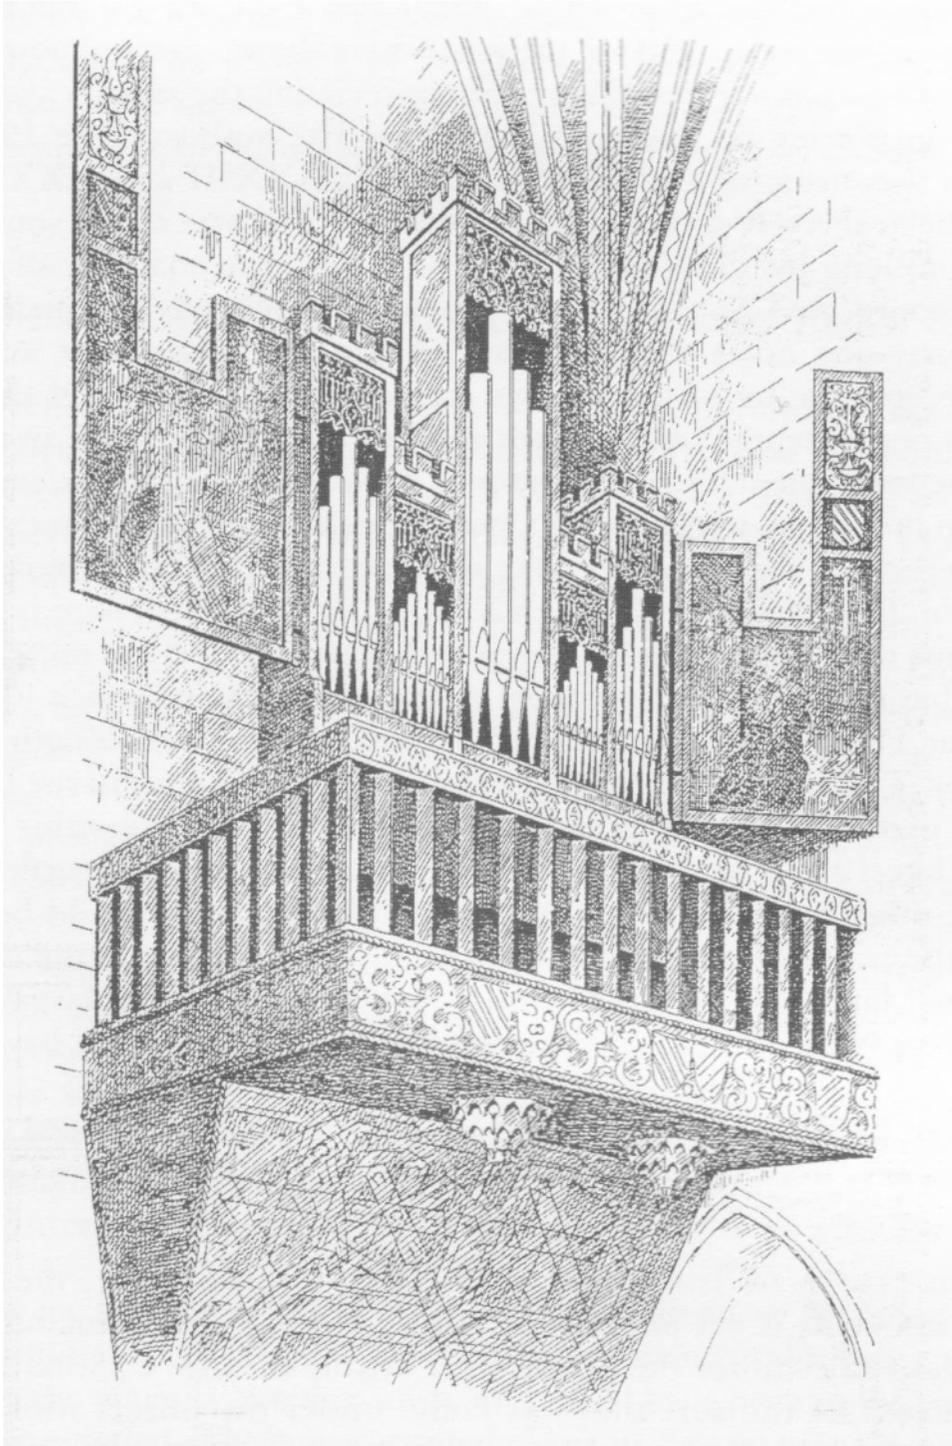
Salamanca organ 15th century

Drawing by Arthur Hill

... such as here in Salamanca
