Investigating the archaeology of the late medieval organ

Martin Renshaw

Barber Institute

Birmingham 25th Feb 2012

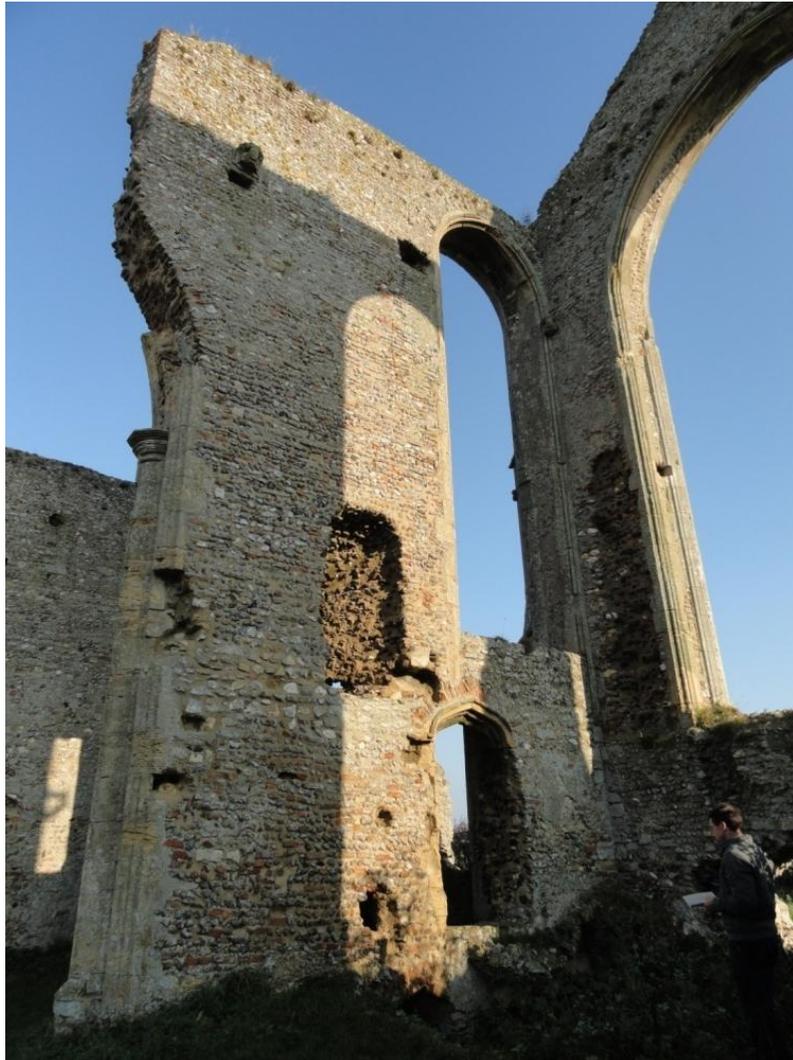
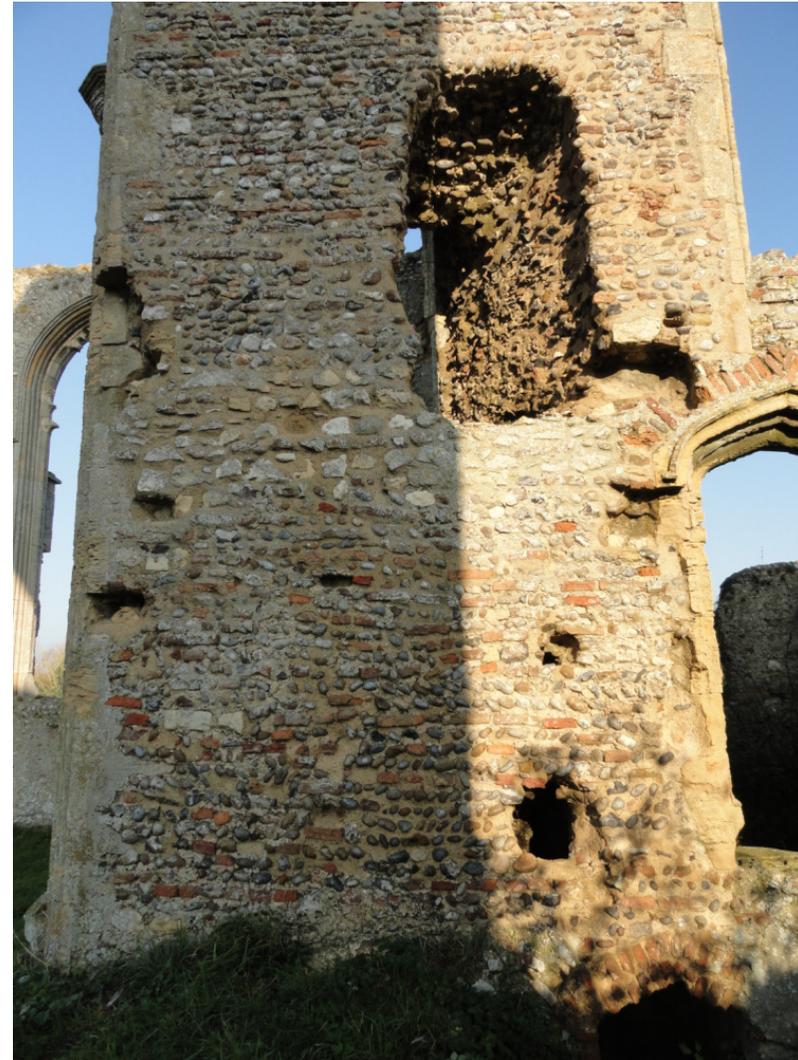
Covehithe

Just a short distance to the north of Walberswick is another equally fine, even larger and equally abandoned church at Covehithe. The same kinds of structural holes are visible in the north sanctuary wall. But here the space available is much less wide from west to east...

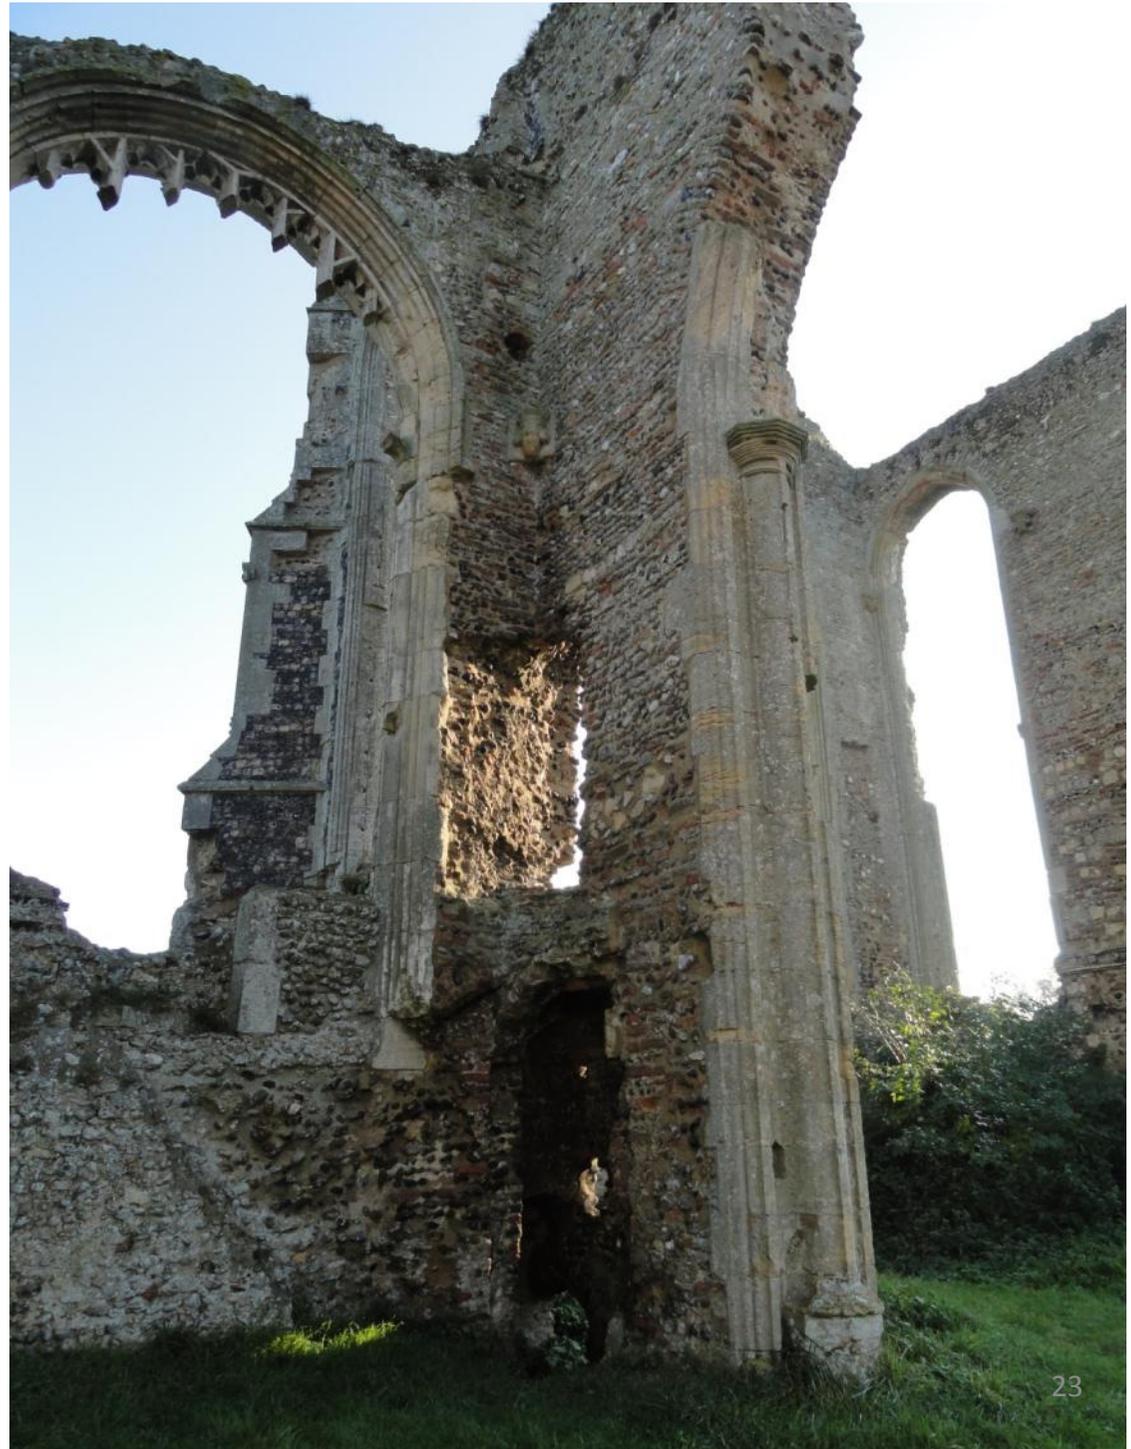
Covehithe

...so the solution adopted was to pierce the wall at gallery level and make an access from the east end of the chapel behind.

The gallery floor here was set at a much more modest height, only about 7 feet up, but again the wall behind goes up to about 30 feet from floor level, so a really tall organ here would be perfectly possible. In fact, an organ in a 'swallow's nest' style of gallery would have fitted well here, and its bellows might have been behind the organ. Even though the vestry behind the organ is only a single-storey building, it seems to have been built just tall enough to have accommodated bellows under its roof.

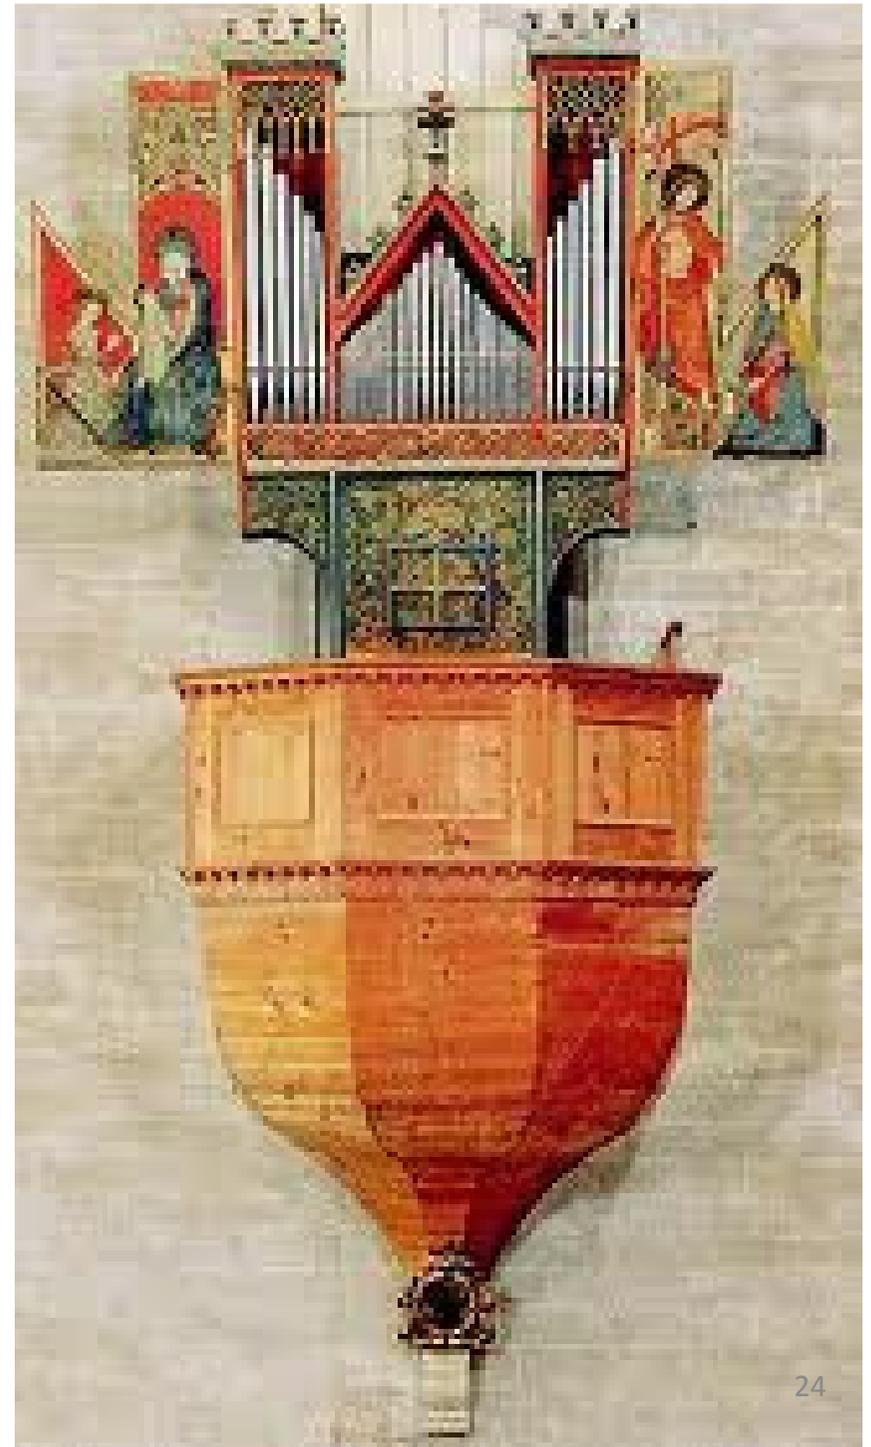
Swallows Nest Organ

Sion, Switzerland

Sitting like birds with outspread wings in their high nests in the forests of soaring arches they were the perfect musical and visual counterpoint to the roofs fluttering with angels' wings

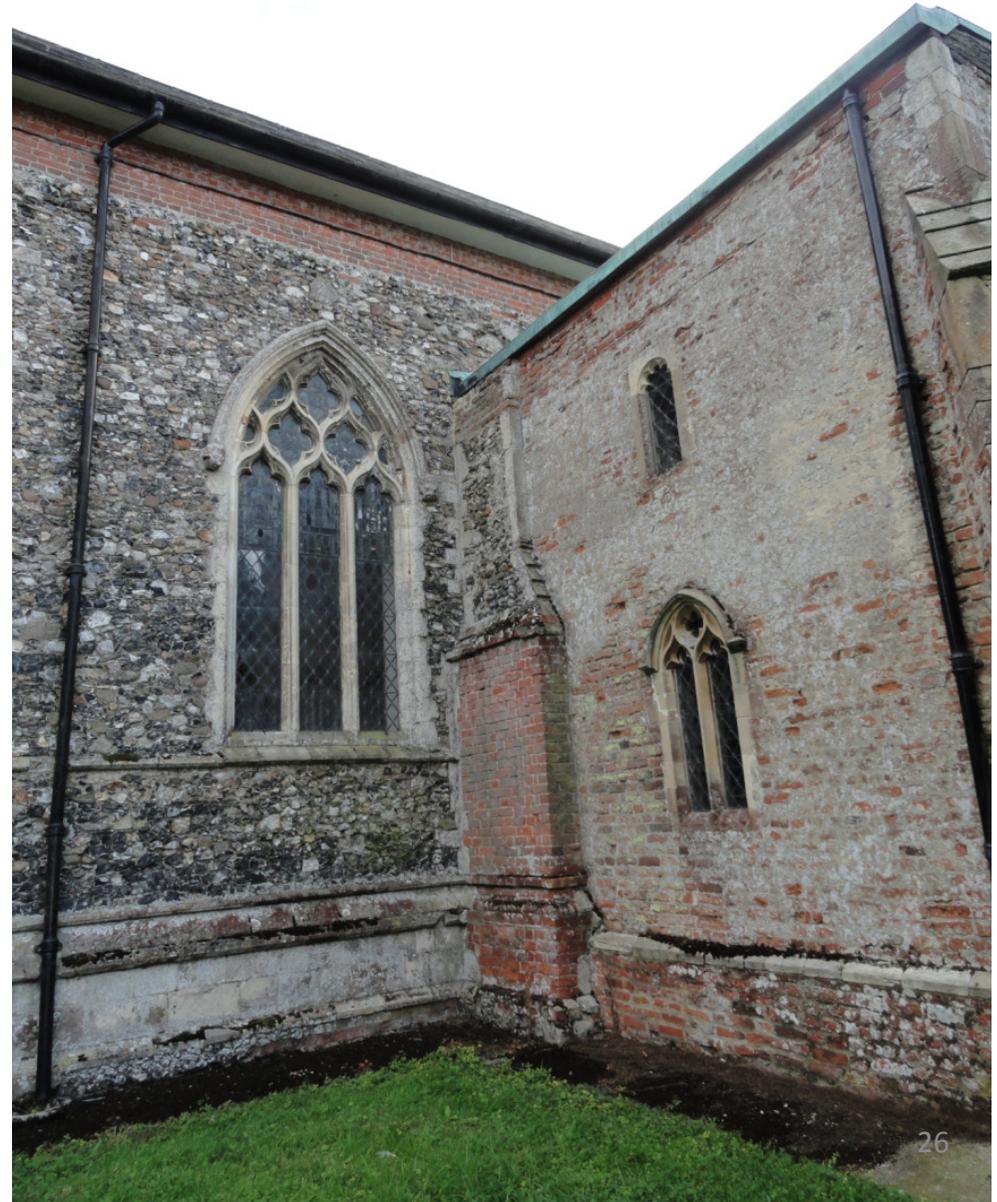
Dennington: hole for wind trunk

If we go up the block stairway to the vestry's upper floor, we find a fine collection of left-over artefacts from the church's last 5 centuries. We also see four socket holes in the west and east walls and, rather amazingly, a hole in the south wall of the upper vestry that goes straight through it, at right angles to the walls, for 21 inches towards the chancel. A wooden blocks closes its chancel end. This hole could not have been a so-called 'squint', made so that anyone in the upper room could see what was happening in the chancel. It would not even have given a view of the door opposite, as it is too high.

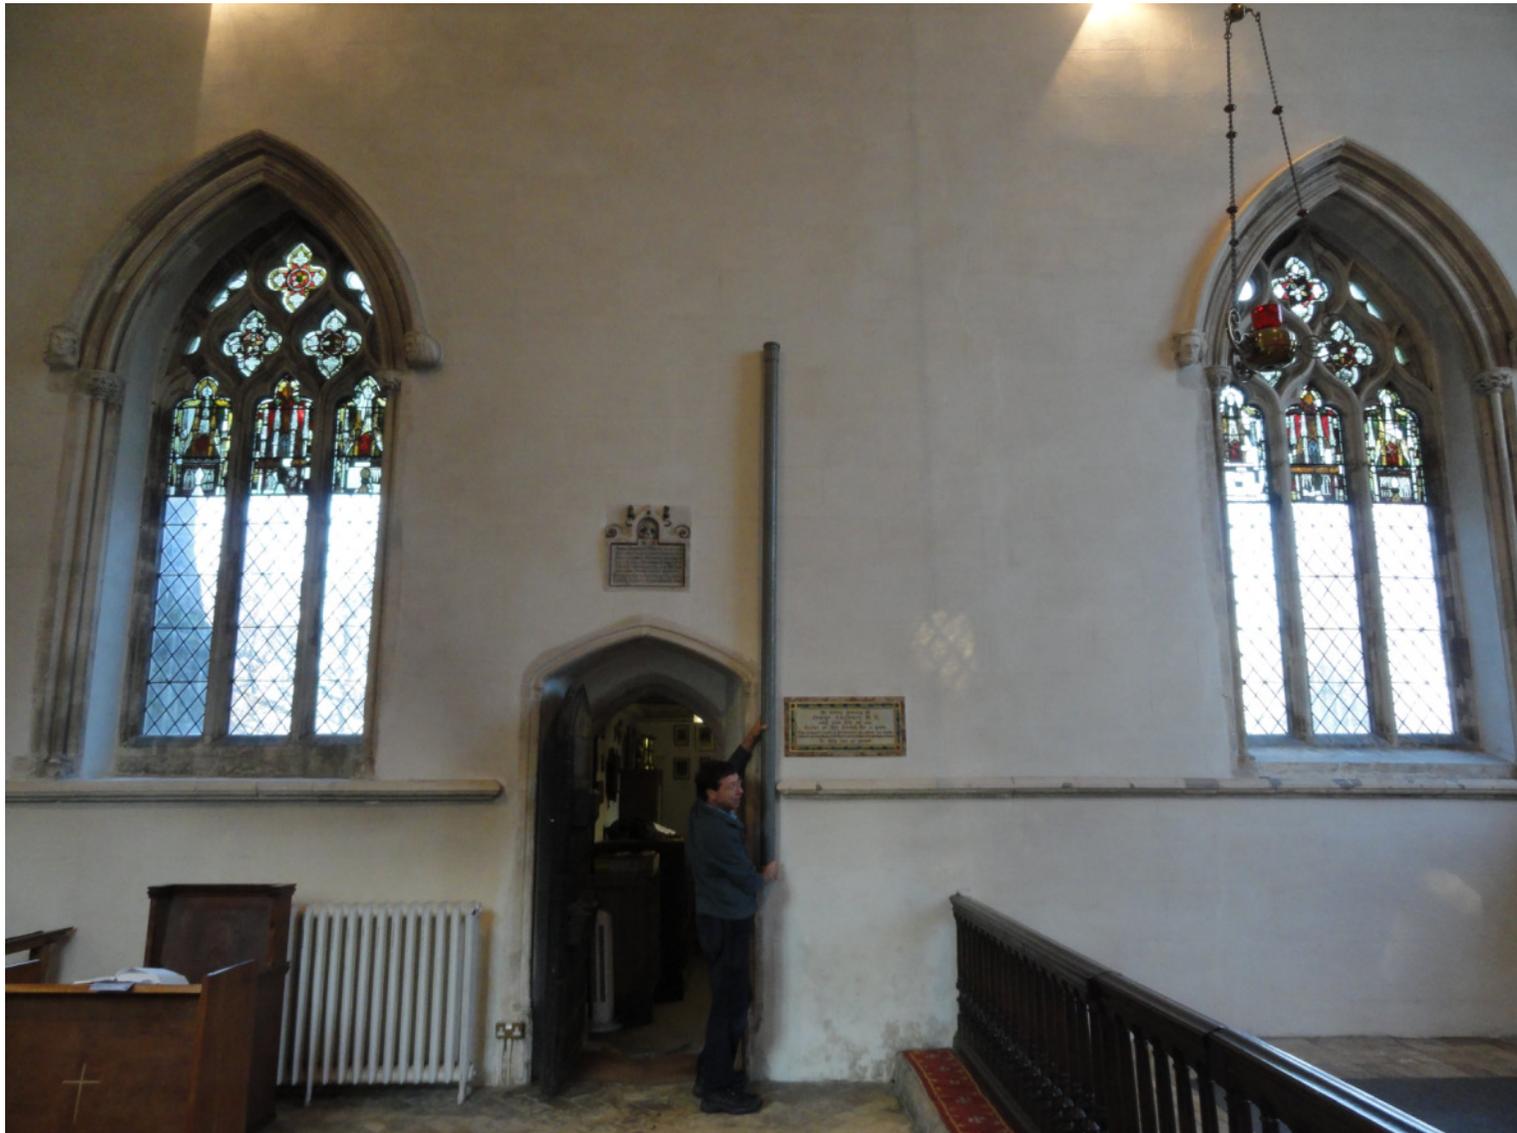
Dennington: position of hole for wind trunk

The hole would in fact have come through the chancel's north wall at the height of the top of the plastic drain pipe I am holding up here at 13 feet 4" above floor level.

A wind-trunk passing through this hole would have fed into the soundboard from the bellows in the upper floor in the same way as I posited at Stoke. The wind-trunk in this hole would have been about 6" by 5" in cross-section, quite enough at the reasonably high pressure normal in older organs, to wind around fifteen ranks of pipes. Going back to the hole that was filled in early in the 17th century, it seems that there must have been a recess in the north chancel wall to take the organ's depth. This would have been about 15" deep, which is the difference between the thickness of the wall and the depth of the existing wind-trunk hole. The organ casework could have been up to 12 feet tall if the gallery floor was around 9 or 10 feet above chancel floor level, which seems likely. We do not know how the player got to the organ, but as there are no signs in the upper vestry, one has to assume that it was by a staircase or ladder in the chancel.

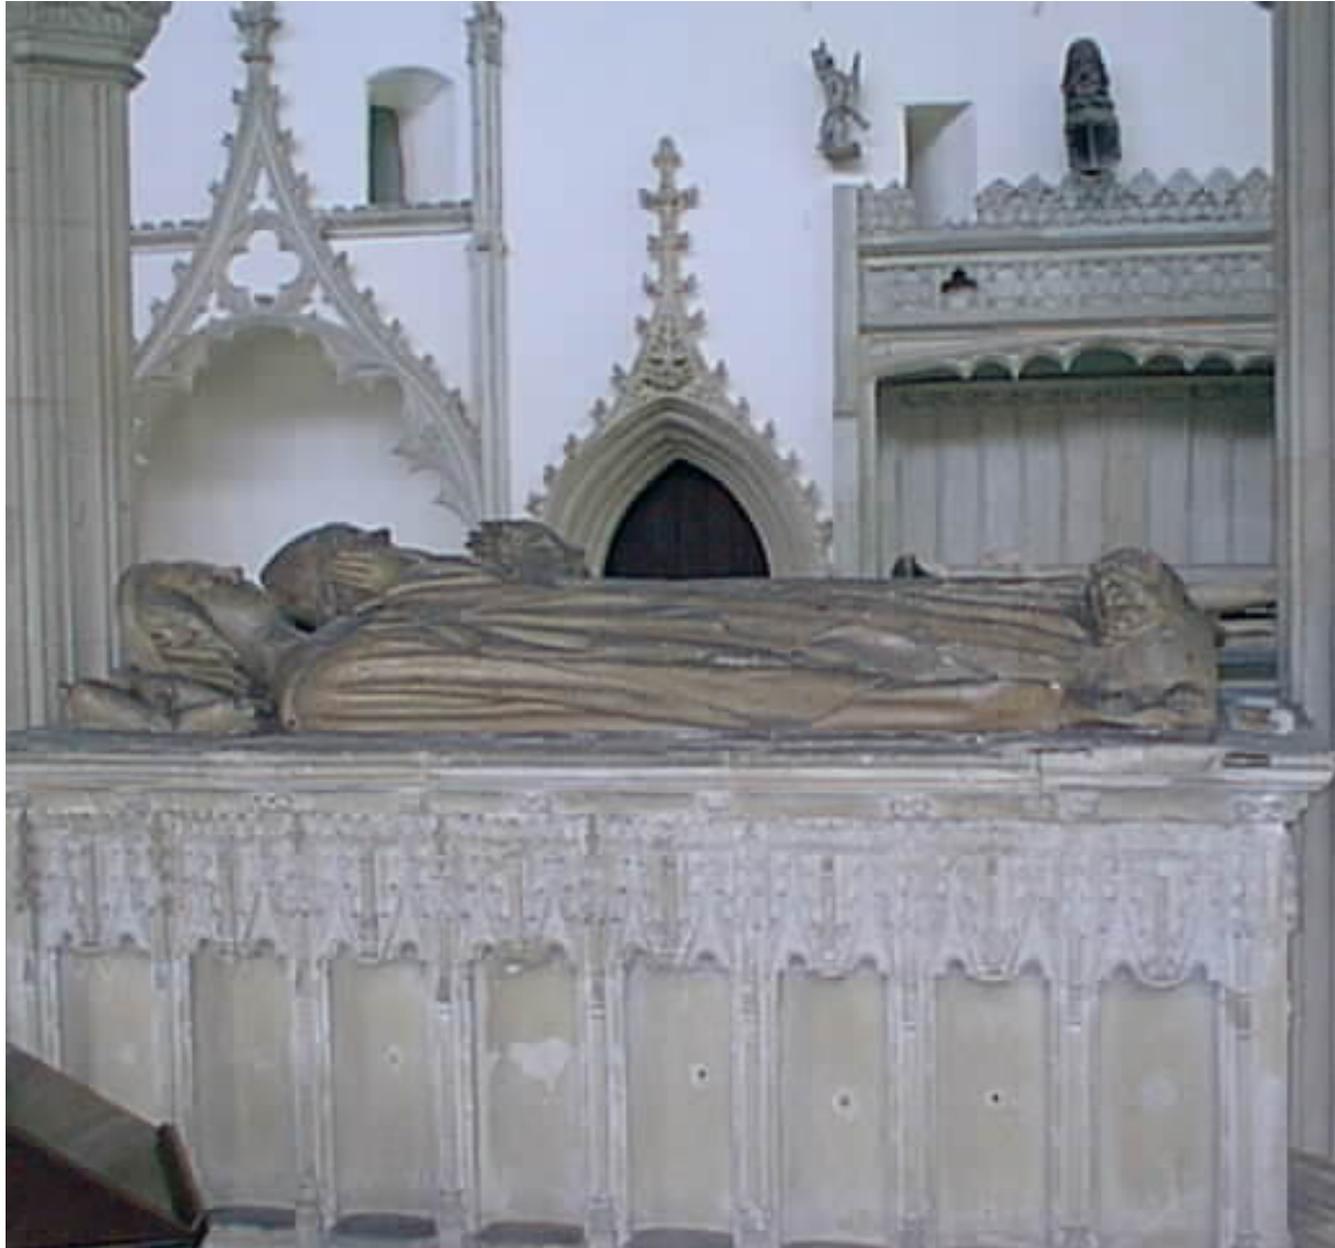
Wingfield: Michael de la Pole & wife.

In the
background, on
the north chancel
wall, two tombs
with holes above
them

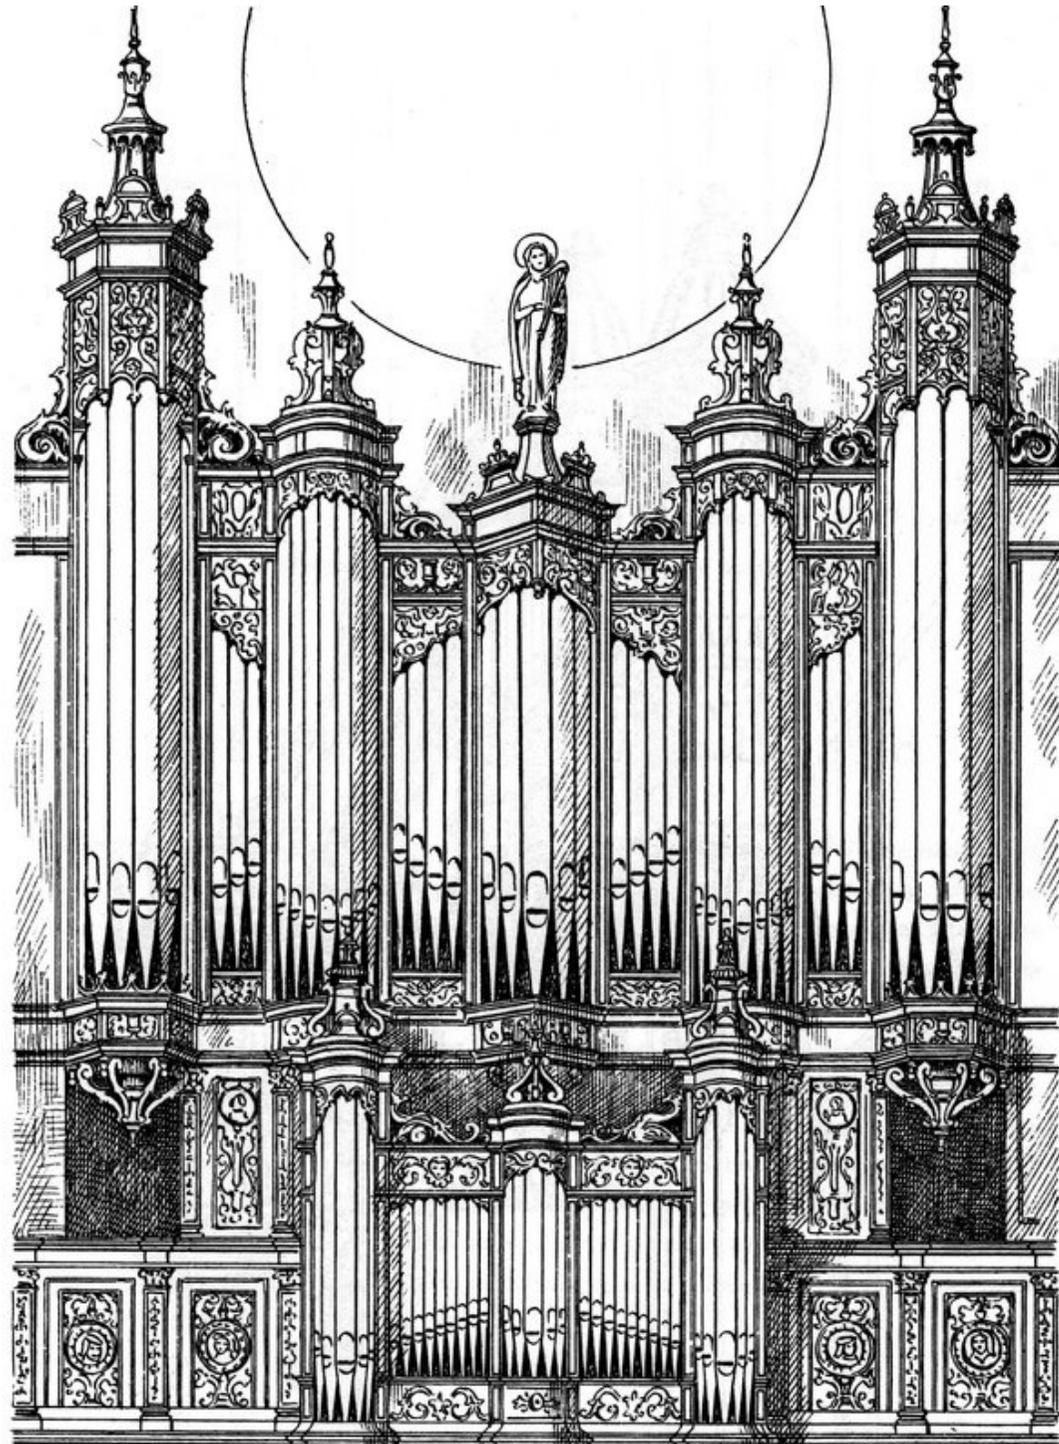
1540 / 1848?

From drawing by
Arthur Hill

It still exists, as I mentioned last year. The casework is still in St Briec Cathedral, northern Brittany, though with a 19th century organ built within it by Aristide Cavallé-Coll (1848).

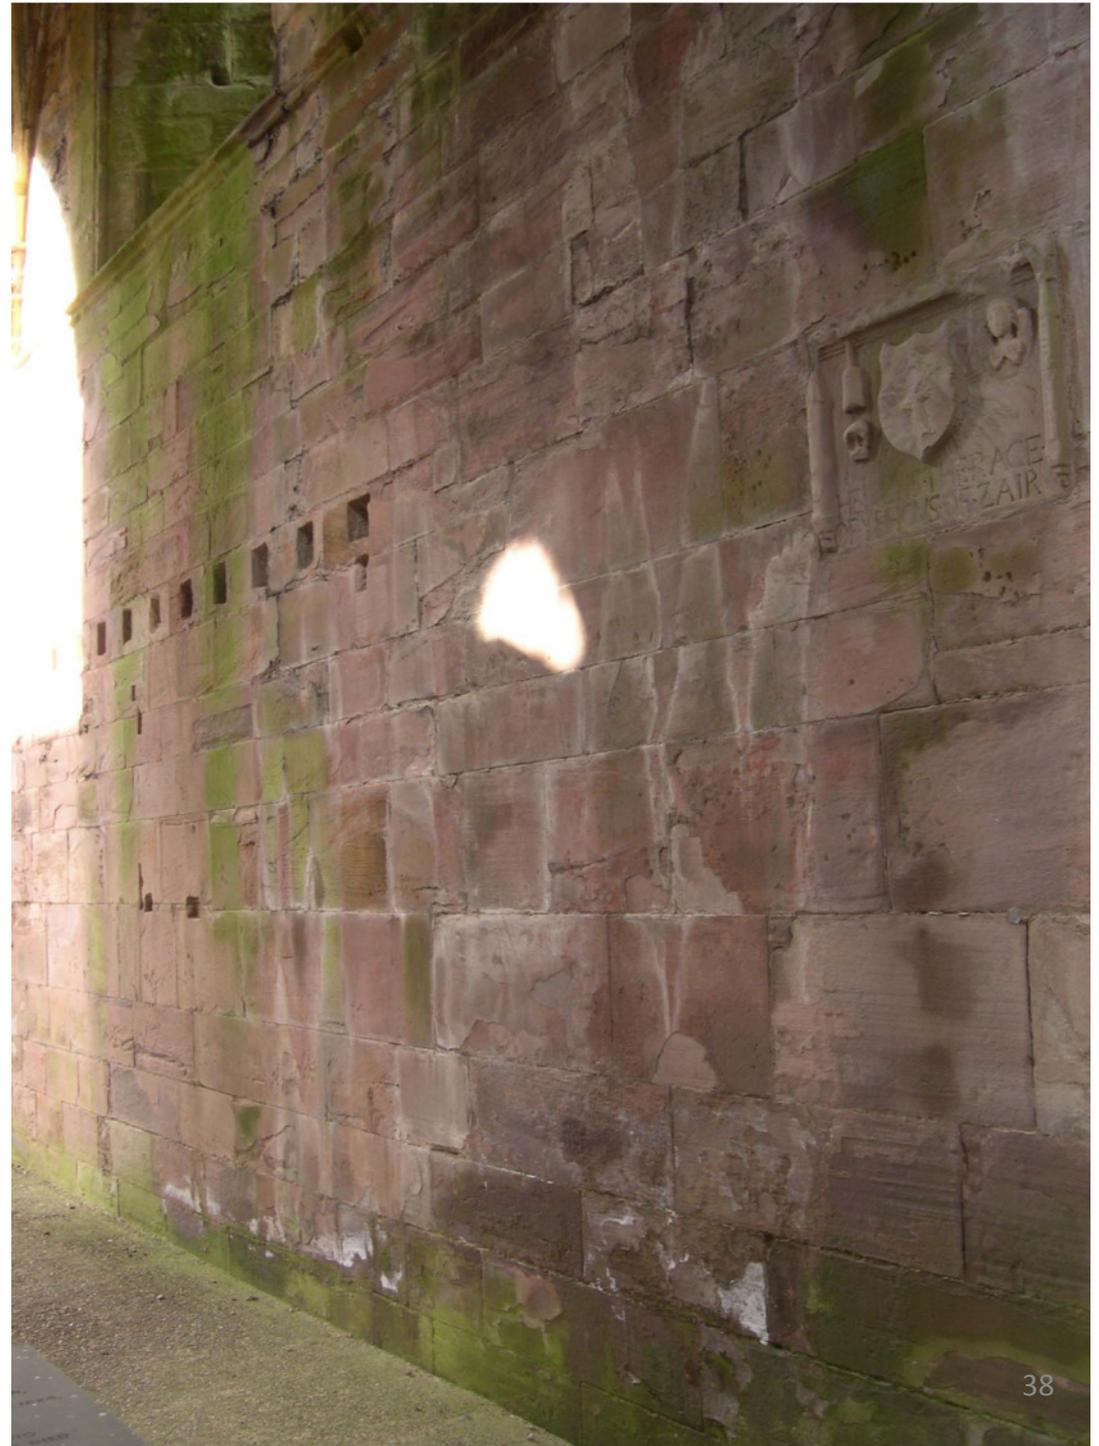
Organ and bellows platform?

North choir aisle,
Melrose Abbey
